## TECHNICAL MEMORANDUM

Subject: Marina Coast Water District – Desalination Plant Evaluation

Date: October 3, 2023

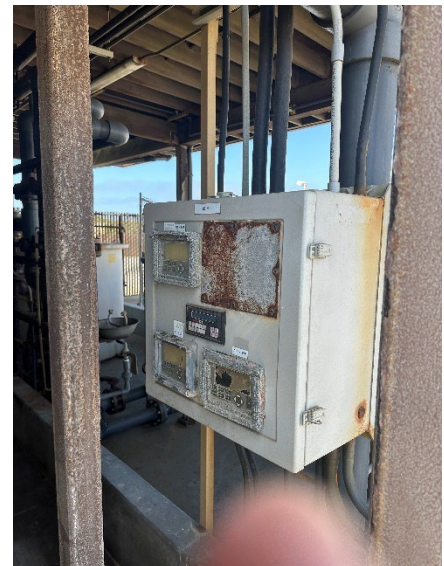
Outside Instrumentation  
Panel

The VFD cabinet cannot close and is exposed to the corrosive marine environment. Looking into the cabinet all the PLC equipment was wet with high corrosion. The PLC and controls are not operable and require replacement. All instrumentation that was seen at the Plant appears to be unusable and requires replacement.

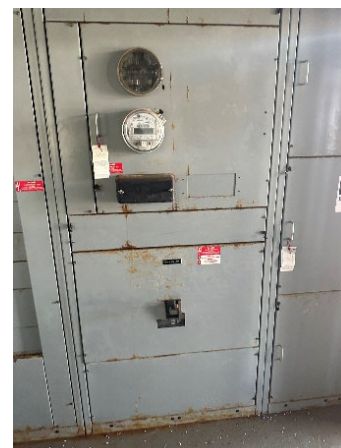
Existing Electric Service

The electrical equipment including the electric service, meter main, motor control centers have deteriorated and require replacement. The electric service is the only thing active at the Plant because it also supplies power to the adjacent MCWD building. This electrical service should be replaced immediately due to its severe corrosion.

All equipment at the Plant is heavily corroded and looks to be inoperable. Most of the equipment would not be economically repairable, due to the age of the equipment being 28 years old, it is reasonable to believe that no replacement parts are available. It is recommended that all equipment at the facility be removed and disposed of, and a new facility be constructed in its place. A new Plant would have the latest controls and equipment that could be easily maintained. A new separate electrical service should be installed as soon as possible to keep the adjacent building in power.

A separate electric service should be installed to power the new Plant when it is constructed. The new electrical service should be sized to meet the power needs of the new Plant.
